Microbiologically Influenced Corrosion of Stainless Steels by Water Used for Cooling and Hydrostatic Testing

IWC-97-53

Summary: Case histories from experience and the published literature illustrate factors which resulted in microbiologically influenced corrosion (MIC) of stainless steel piping, storage tanks and heat exchangers by waters used for hydrotesting, cooling and other purposes. Practices which will prevent or reduce potential for MIC, including material substitution, are discussed, along with efforts to heighten awareness of the problem.

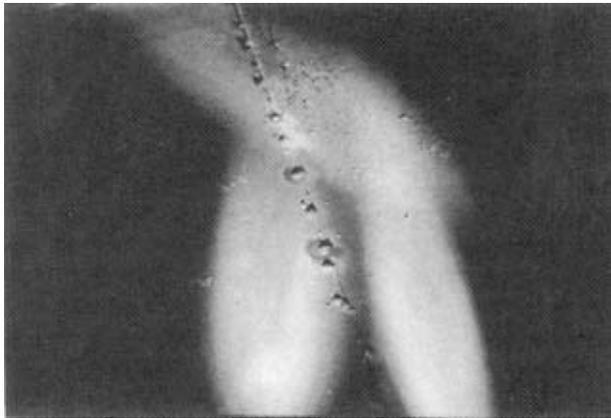
Figure No. 1

The problem surfaced when water was found dripping from circumferential butt welds in nominal 1/8 inch wall 304L and 316L piping approximately one and four months respectively after the hydrotest. Internal inspection showed pits in and adjacent to welds under reddish-brown deposits. Tank manways were uncovered and similar conditions were found. As shown in Figure 1, bulky, reddish-brown deposits were strung out along weld seams in the tank bottoms.

Mound-like deposits along weld seam in bottom of Type 304L SST tank after several months exposure to well water at ambient temperature.

All affected piping was replaced in kind before the new facilities were placed in service. Demineralized water replaced well water as the hydrotest medium, and piping was drained and dried or placed in service immediately following the test. In the very few instances where demineralized water was inadvertently left in a pipeline for extended periods, inspection showed no evidence of MIC. The tanks were repaired by first sandblasting to uncover all pits, grinding out each pit to sound metal and welding with the appropriate SST filler metal. In lieu of re-hydrotesting, all repairs were examined for soundness with liquid dye penetrant. Piping and tanks have been in corrosive service for nearly 30 years to date with very few leaks, indicating the inspection, replacement and repair program was effective.

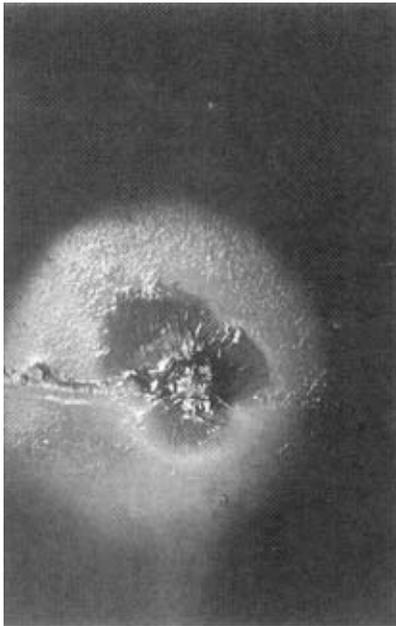
Figure No. 2

Figure 2 is a closeup of a typical mound-like deposit still wet with test water. The brilliantly colored deposit was slimy and gelatinous in appearance and to the touch, and measured 3 to 4 inches across. At one point during the investigation, a similar deposit on a weld which was covered with about 6 inches of water was thoroughly dispersed by hand. Twenty-four hours later, the "deposit" had returned in somewhat diminished form to exactly the same location!

Closeup of a wet deposit

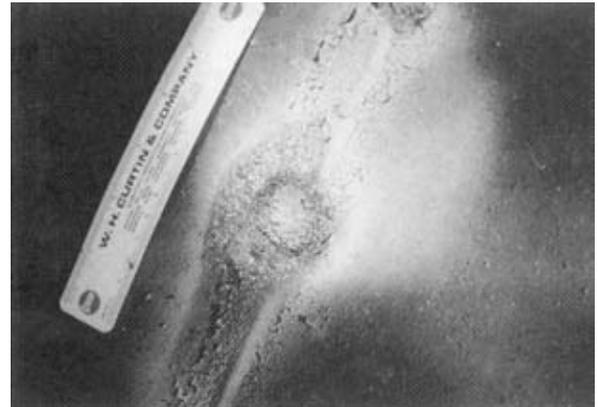
Figure No. 3

Figure 3 shows a nearly dry deposit. After wiping the deposit clean, a dark ring-shaped stain outlining the deposit over the weld was noted, Figure 4. There was, however, no evidence of pitting or other corrosion, even after light sanding with emery. Finally, probing with an icpick revealed a large deep pit at the edge of the weld as shown in Figure 5.

Closeup of a dry deposit.

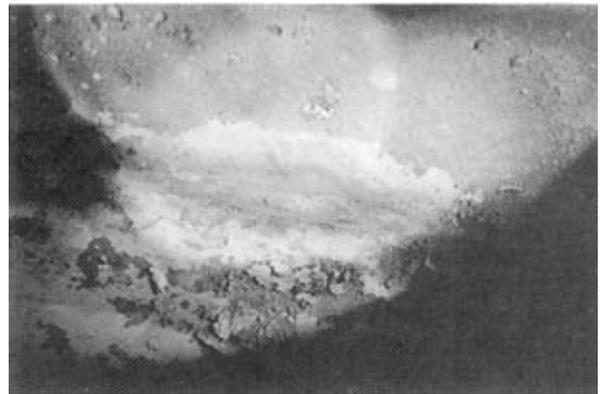
Figure No. 4

After removal of deposit, showing ring-shaped stain around the weld.

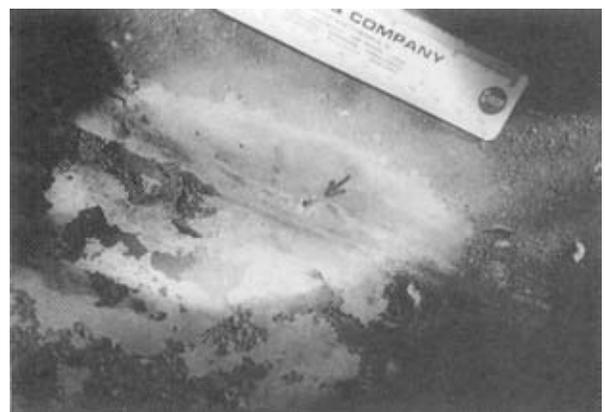
Figure No. 5

Large pit at edge of weld in Figure 4 disclosed by probing with icepick.

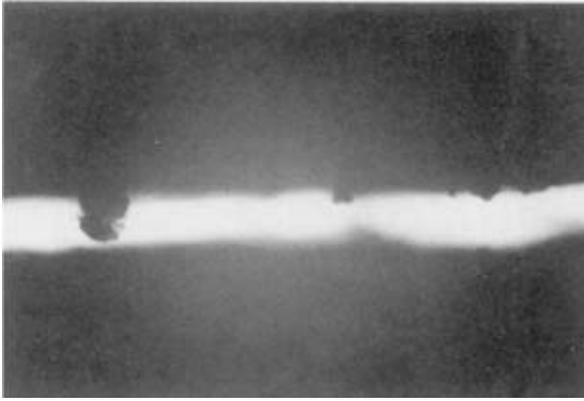
Figure 6 is a radiograph of this weld seam showing the large pit which nearly consumed the entire width of the weld bead, plus several smaller pits.

Figure No. 6
Radiograph of a pitted weld seam in a 304L tank.

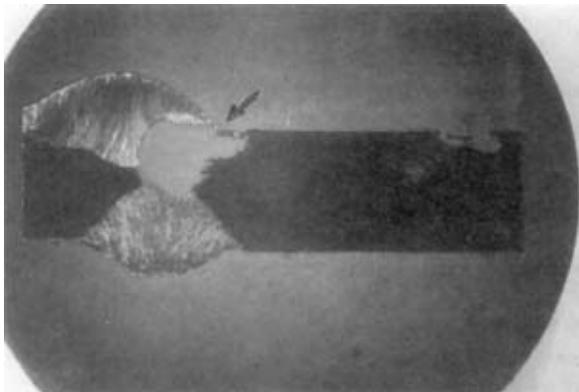
A cross-section through a large pit in a 3/8 inch thick 304L tank bottom is shown in Figure 7.

The characteristics were a tiny "mouth" at the surface, and a thin shell of metal covering a bottle-shaped pit which had consumed both weld and base metal. There was no evidence of intergranular or interdendritic attack of base or weld metal respectively. However, pitted welds in a 316L tank showed preferential attack of the delta ferrite stringers, Figure 8.

Figure No. 7
Metallographic mount of a cross section through a pitted weld seam. Arrow points to small "mouth" on surface.

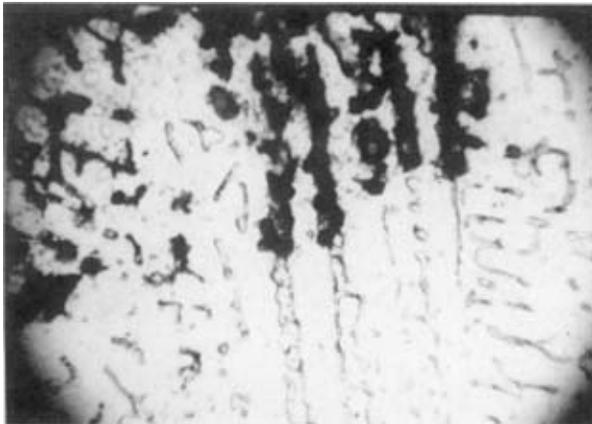
Figure No. 8
Photomicrograph showing preferential attack of delta ferrite stringers in 316L weld metal. 250X

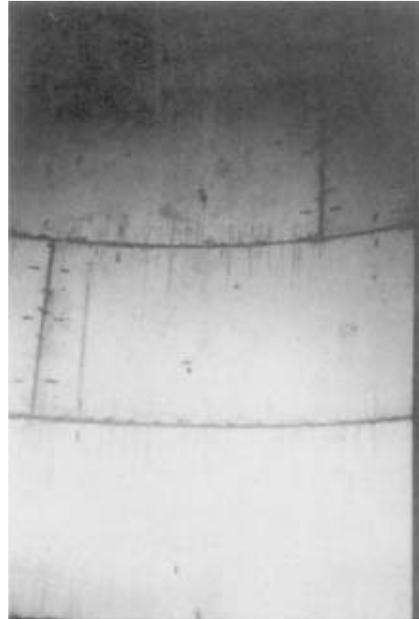
This 316L tank was left full of hydrotest water for a month before draining. The bottom showed severe pitting under the typical reddish-brown deposits along welds. In addition, however, vertical rust-colored streaks, Figure 9, were found above and below the sidewall horizontal welds, with deep pits at the edges of the welds associated with each streak, Figure 10.

Figure No. 9
Rust-colored streaks normal to horizontal weld seams in sidewall of 316L tank.

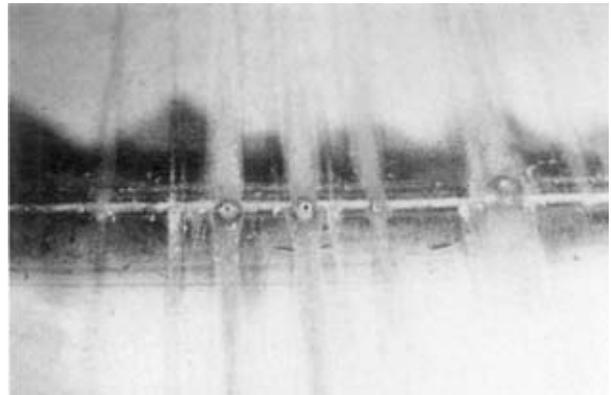
Figure No. 10
Closeup of streaks shown in Figure 9.

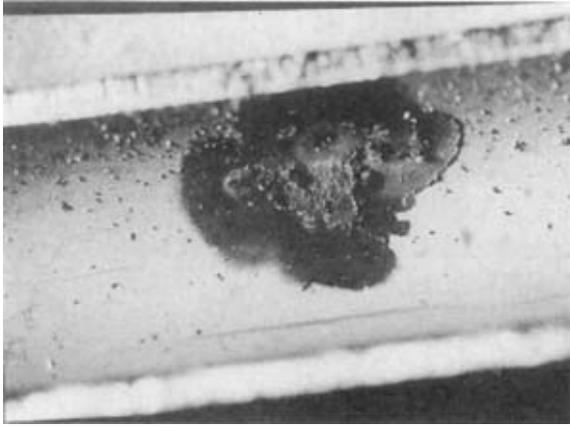
Examination showed severe biological fouling of the 304 SST condenser heads, channels, tube sheets, and tubes, as well as 2 to 3 ft. of biologically active sludge in the cooling tower basin. Fiberoptic video-probe inspection of internal tube surfaces after hydroblast cleaning showed random, discrete reddish-brown deposits or stains with pits inside the stains, Figure 11. A crosssection through a pitted area is shown in Figure 12.

Figure No. 11
Reddish-brown deposit/stain and pits on internal surface

The final long-term remedy was replacement with high nickel-chrome-molybdenum alloy tube bundles and water treatment with molybdate and orthophosphate anodic corrosion inhibitors coupled with zinc, polyphosphate, and tolytriazole; dispersants; and sodium hypochlorite, methylenebis (thiocyanate), and 2-(thiocyanomethylthio) benzotriazole for biological control.

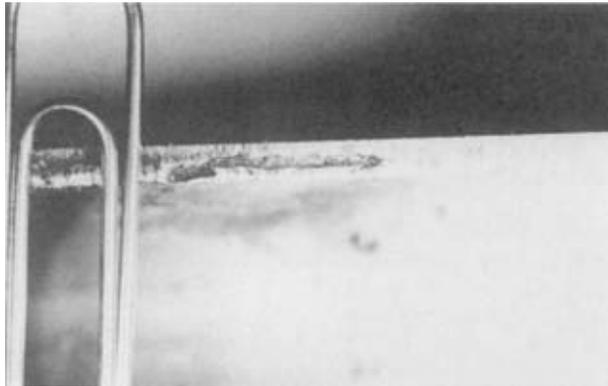
Figure No. 12
Cross-section through a pit in 304 SST tube showing sub-surface "tunnel".

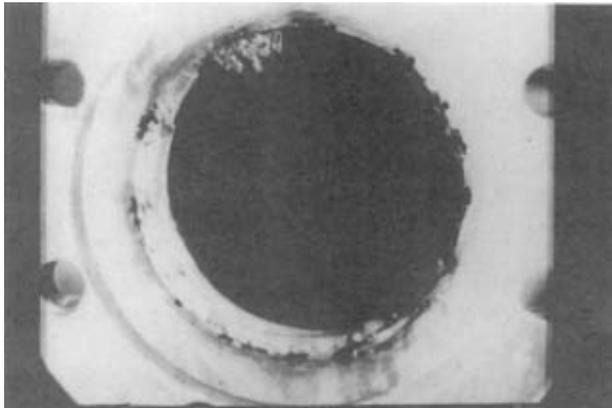
corrosion in and near flanged and gasketed joints. These corrosion sites, in low water velocity areas, were surrounded by voluminous bio-deposits, tan to brown in color and slimy to touch, Figure 13.

Figure No. 13
304 SST flange showing one remaining deposit. Numerous similar deposits were washed away when the joint was opened. This flange had been covered with an asbestos gasket and a SST blind flange.

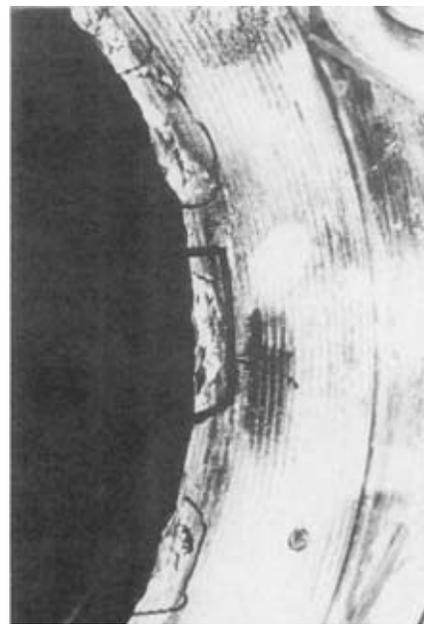
Corroded surfaces at the edges of gasketed surfaces were characterized as broad, open "gouging" type pits, bright and active under the deposits, Figure 14.

Figure No. 14
Closeup of flange in Figure 13 after cleaning. Shows open "gouging" corrosion that was directly under deposits.

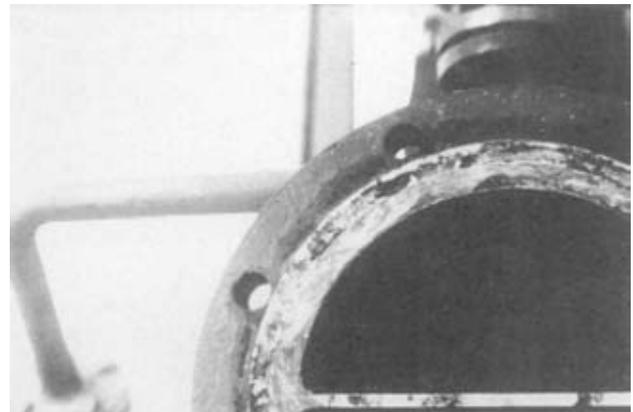
Adjacent corroded surfaces in contact with the asbestos gasket material were covered with black deposits which emitted hydrogen sulfide gas when treated with hydrochloric acid, Figure 15.

Figure No. 15
304 SST condenser head flange showing areas of crevice corrosion, some filled with black FeS, on gasket surface. Bacteria deposits covered the inside edge of the gasket in these areas.

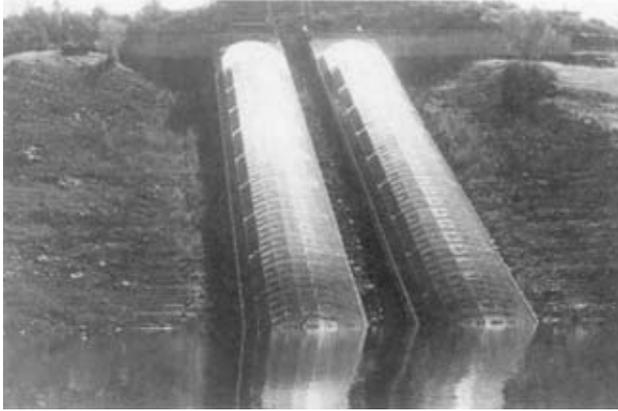
The trash racks, each 680 feet long by 46 feet wide (Figure 16) were installed in 1968 and thoroughly inspected in 1991. There was no evidence of general corrosion, pitting or crevice attack on any component,

Figure No. 16
304 SST trash racks on a fresh water lake in California.

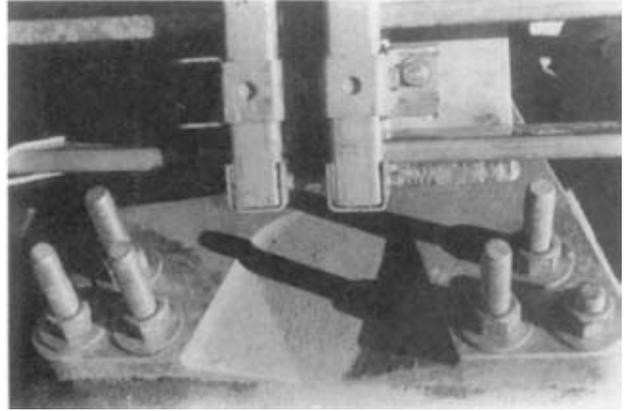
Figure No. 18
Trash rack weld; no evidence of corrosion.

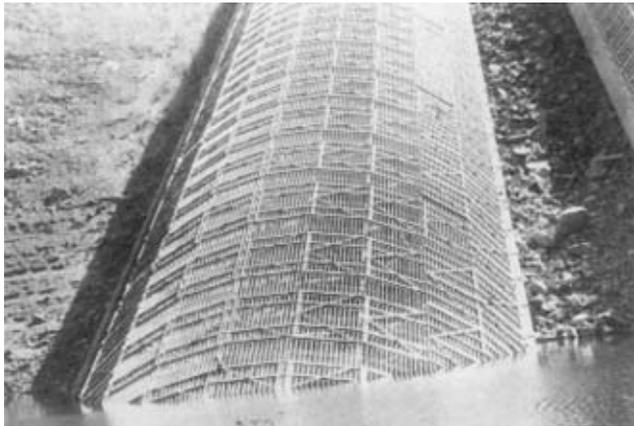
Figure No. 17
Closeup view of a trash rack showing half-hard 304 SST components.

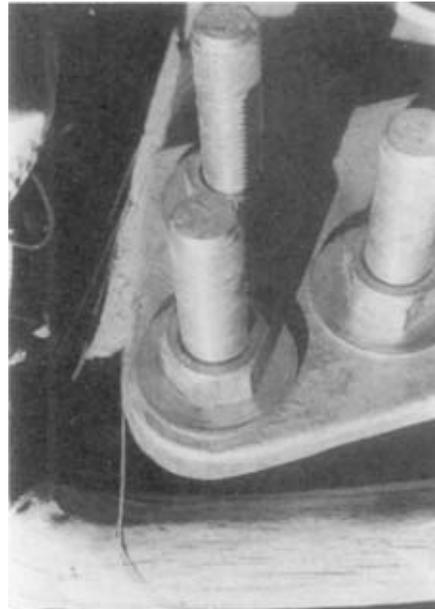
Figure No. 19
Trash rack fasteners; no evidence of corrosion.
